SERVICE BULLETIN

APPLICABILITY: 2013-14MY Legacy and Outback Models with 2.5L FB Engine
 2011-14MY Forester Models with 2.5L FB Engines
 2012-13MY Impreza and 2013MY XV Crosstrek Models with 2.0L FB Engine

NUMBER: 02-157-14R
DATE: 08/28/14
REVISED: 01/07/15

SUBJECT: Surface Treatment Change To Oil Control Piston Rings

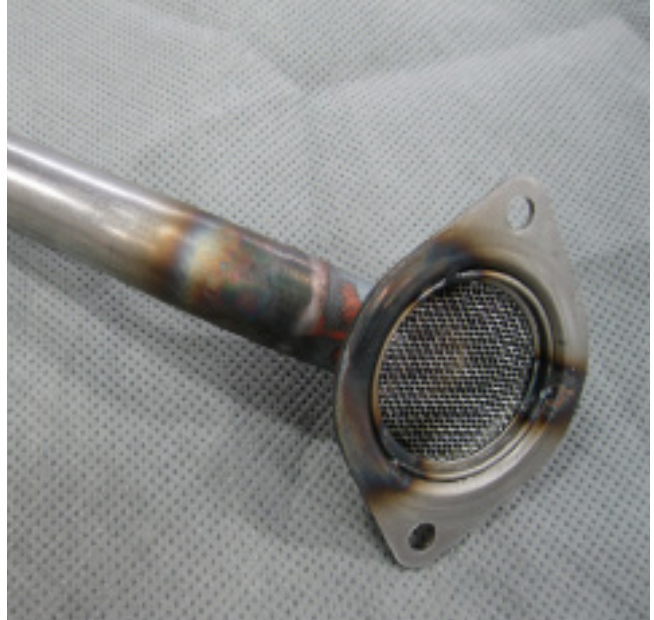
Oil Pick Up Tube/Filter Screen Assembly

- Before installing the upper and lower oil pans, **always thoroughly clean and inspect the pick-up tube and screen.** Always use new o-rings on the pick-up tube and both oil pans during reassembly.
